Role of hydrogen in service degradation of the physical and mechanical properties of structural steels

Hryhoriy Nykyforchyn*

*Karpenko Physico-Mechanical Institute, Lviv,
Ukraine*

*13th Polish-Ukrainian-German
Summer School on Fracture Mechanics
September 3-6, 2013,*

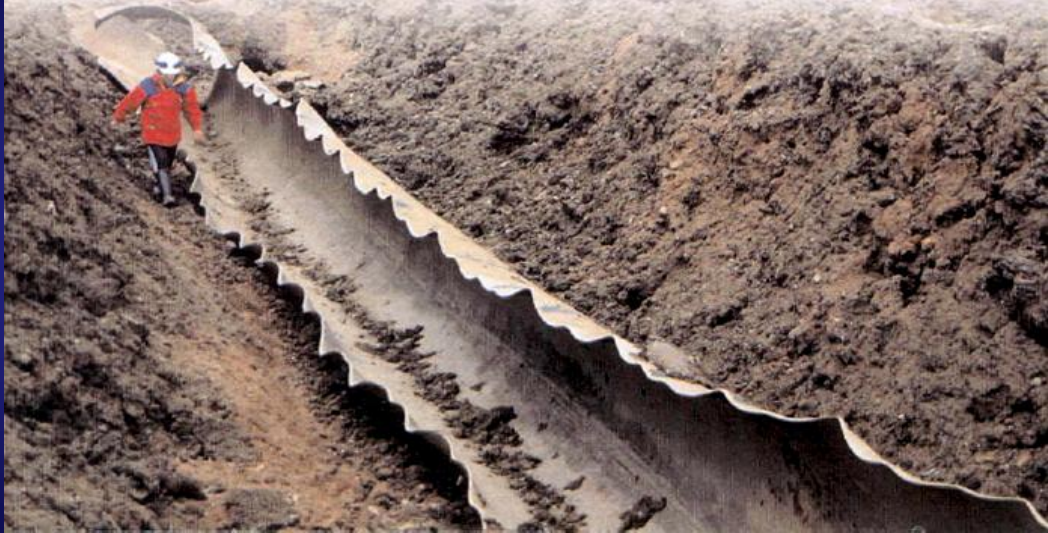
Failure of transit gas pipeline

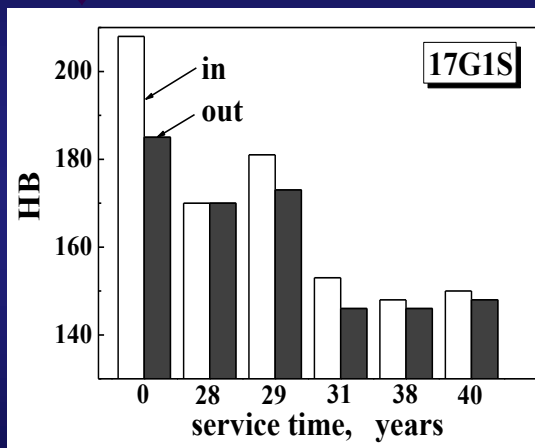
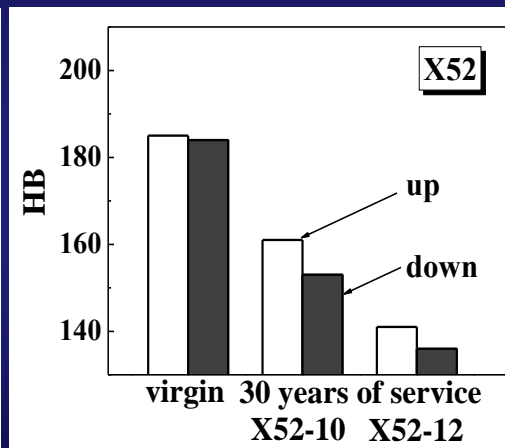
Low carbon gas pipeline steels after 28-40 years of service

Steel	Service, years	Part of pipe	σ_{ys} , MPa	σ_{UTS} , MPa	RA, %	Elong, %	Hardening,	$J_i/J_{0.2}$, kN/m
X52	–		355	475	72.9	22.7	0.59	86/412
X52-12	30	Down	268	451	64.4	20.8	0.74	50/127
		Top	255	460	62.5	22.9		
X52-10		Down	362	536	54.6	29.7	0.82	37/79
		Top	335	538	55.0	28.8		
17G1S	–		378	595	79.0	20.2	0.58	203/315
	28		403	590	68.2	20.5		
	29		345	547	71.1	19.6	0.76	
	31		419	574	73.8	21.8		87/201
	38		357	520	73.1	25.4	0.97	
	40		302	515	69.2	26.3	0.75

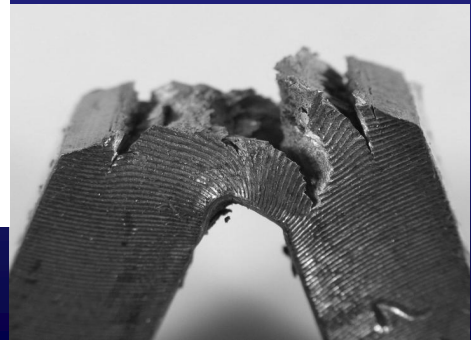
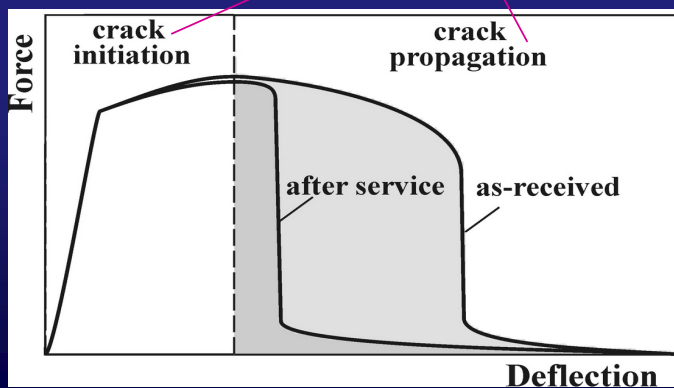
17G1S low carbon gas pipeline steel after 28-40 years of service

Charpy testing of X52 steel

Total fracture energy (1)
and its components of crack
initiation (2) and crack
propagation (3)

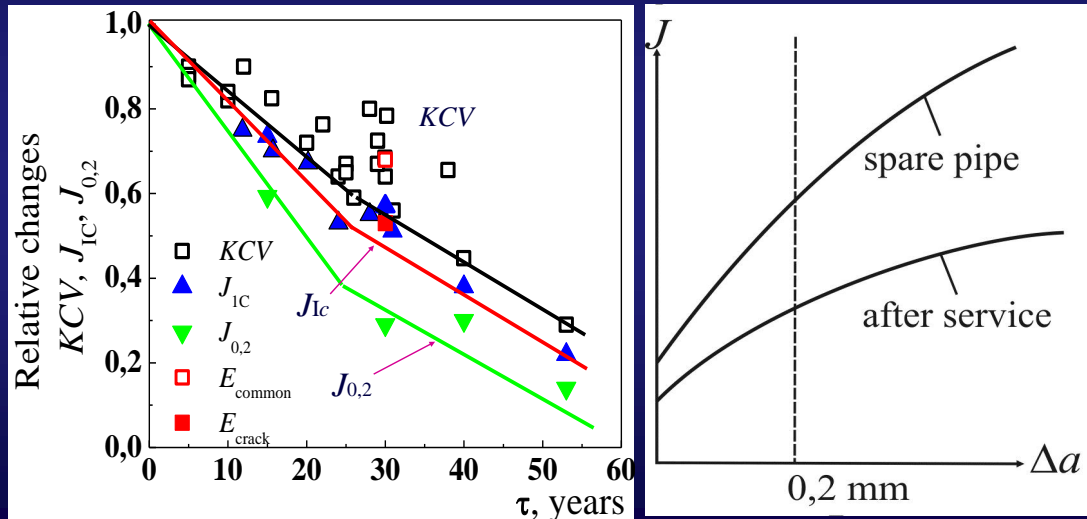
Comparison of sensitivity to degradation the characteristics of brittle fracture resistance for some pipeline steels 14KhGS, 17GS, 17G1S, X52, X60

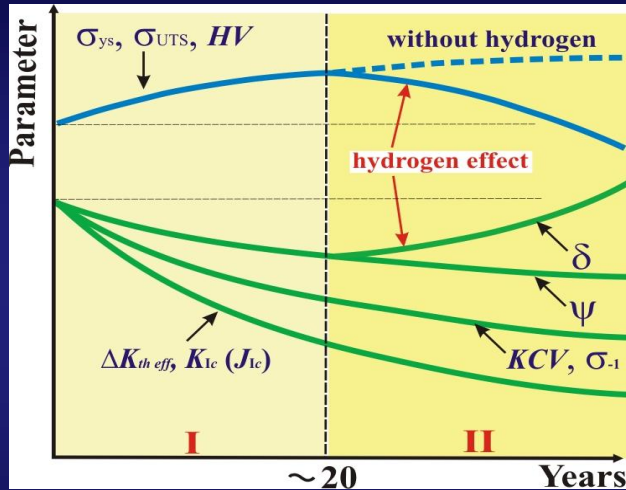
Two principal stages of in-bulk material degradation

I Deformation aging **II Damaging**
30 years of service – critical age
from the point of considering
in-bulk material damages !

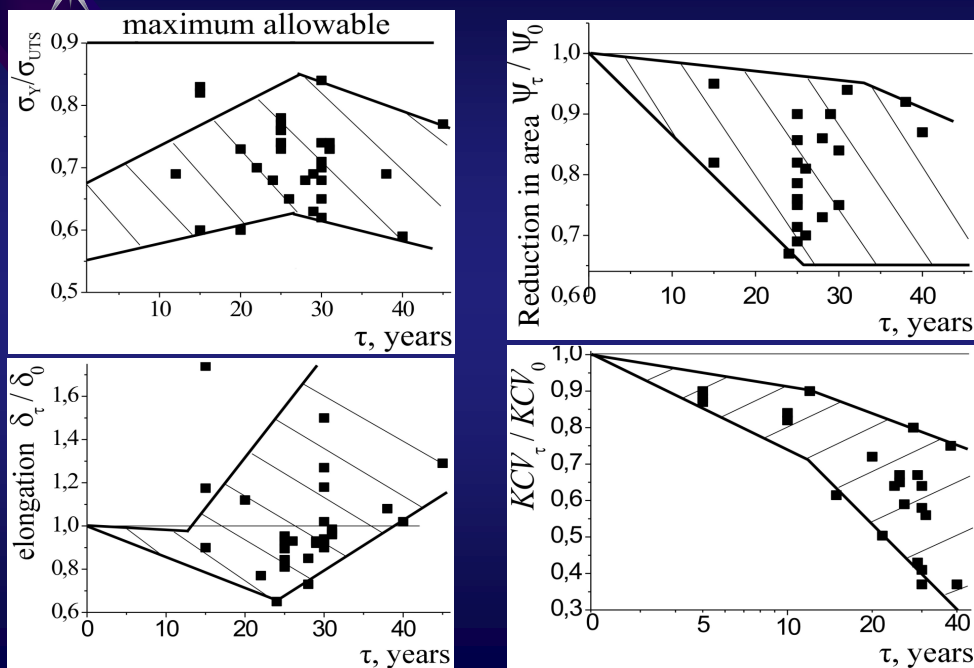
Generalized data about in-service degradation of some mechanical properties

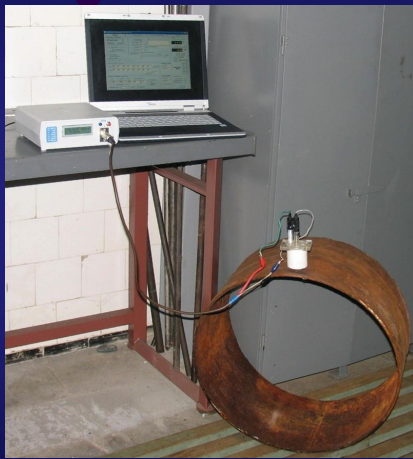
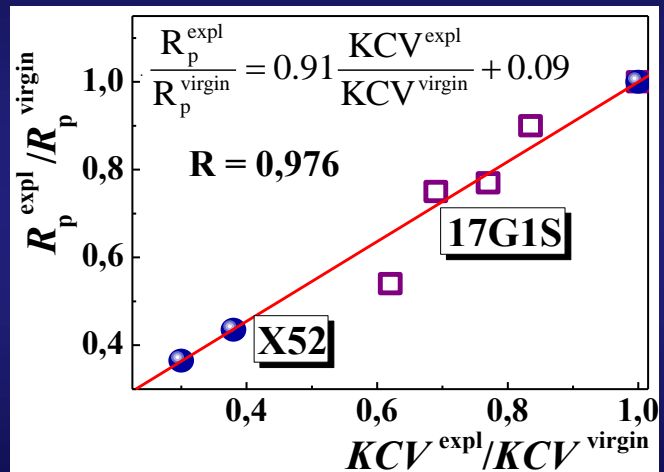
Correlation between degradation the mechanical (impact strength KCV) and electrochemical (polarization resistance R_p) characteristics

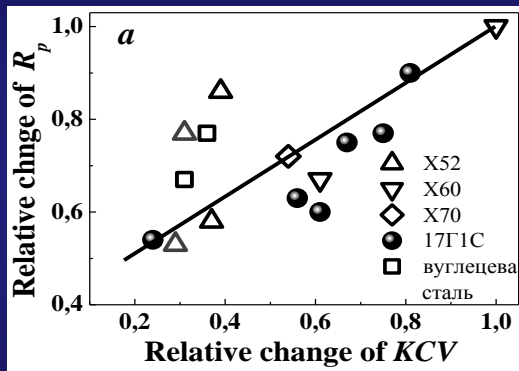
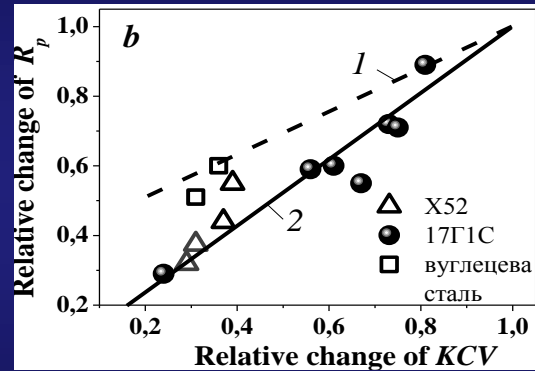
Working environment should not be obligatory used as environment for monitoring of electrochemical characteristics !
